COLORADO DEPARTMENT OF PUBLIC HEALTH
AND ENVIRONMENT

SITE INSPECTION

ANALYTICAL RESULTS REPORT

UPPER ANIMAS WATERSHED (CERCLIS ID # CO0001411347)

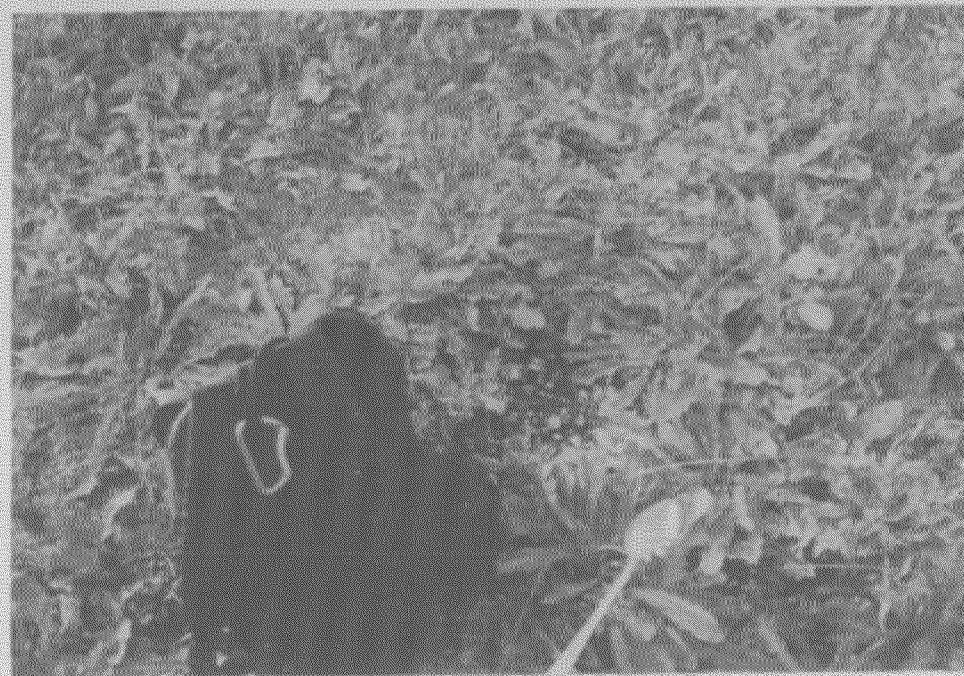
Description of Photo: OP-SL-1 Residential Soil N. Of 857 Reese
Date: September 16, 1997 Time: 1715
Direction facing: West (35mm film)

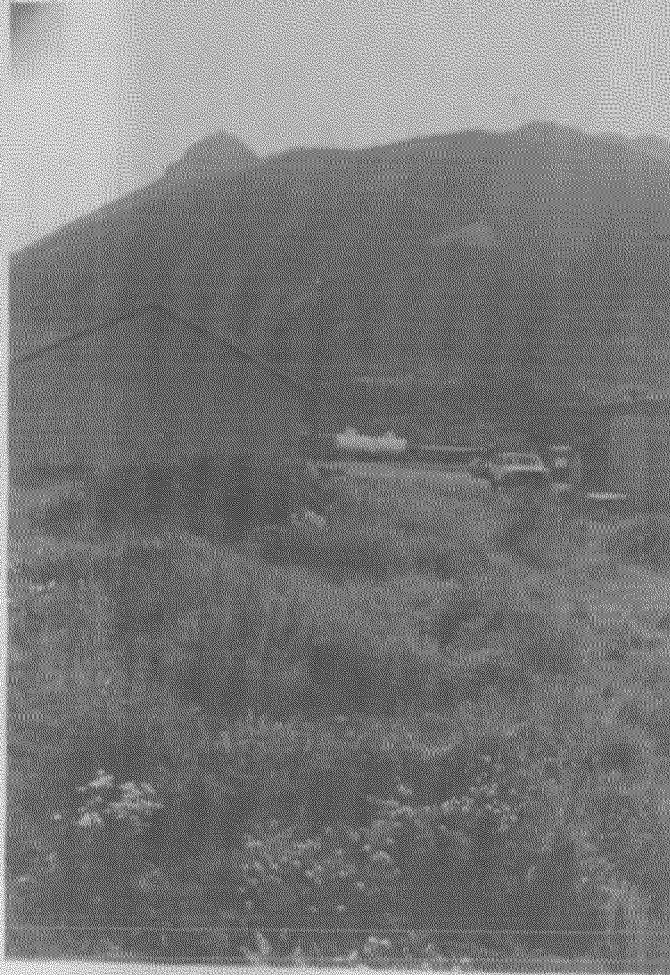
Description of Photo: OP-SL-2 Residential Soil @10th and Bluff
Date: September 16, 1997 Time: 1645
Direction facing: Southwest (35mm film)
